Manhole Inspection Summary

Manhole # S25I__047MH

Insp Date: **3/21/08 10:39 AM**

Location Address: **1120 Hollins**

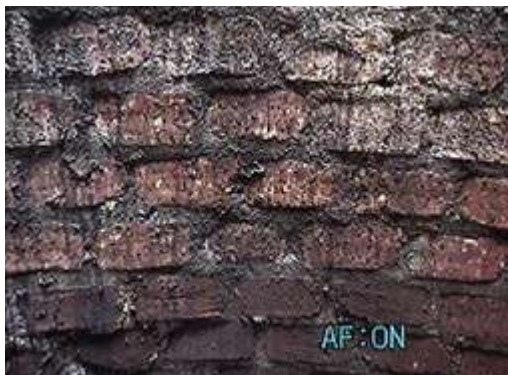
Defect 5

infiltration around barrel

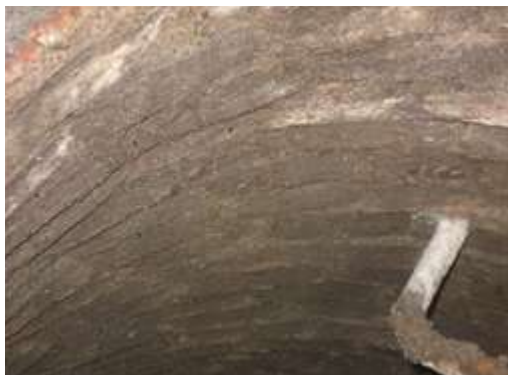
Defect 3

sign of infiltration

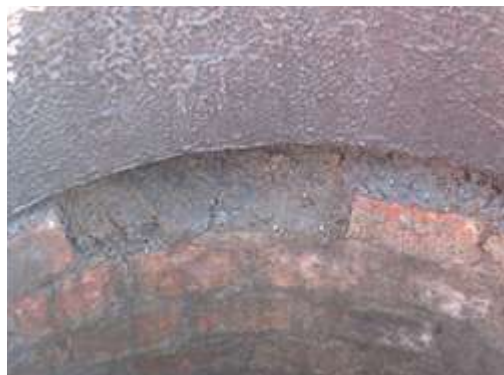
Defect 2

Condition: ☐ Sound ☐ Cracked ☐ Root Intrusion ☒ Loose Brick ☒ Deteriorated

missing brick chimney

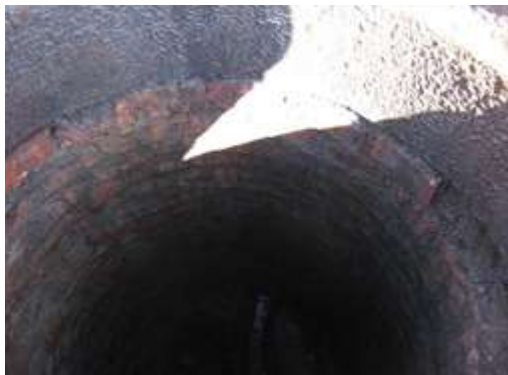
Defect 1

Infiltration: ☐ None ☒ Joint ☐ Cracks ☐ Mortar ☐ Roots ☒ Wall

sign of infiltration coming from chimney-frame joint as well as lid

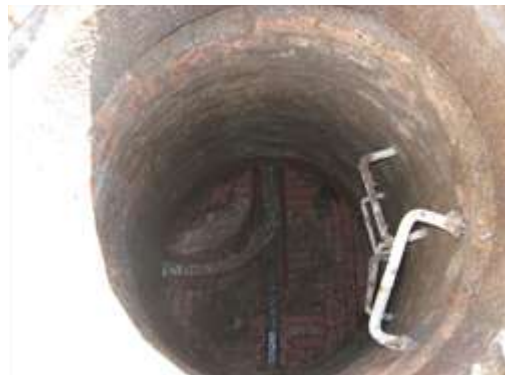
Defect 6

Count: **6** Missing: **1** ☒ Corroded

corroded steps, 1 step missing

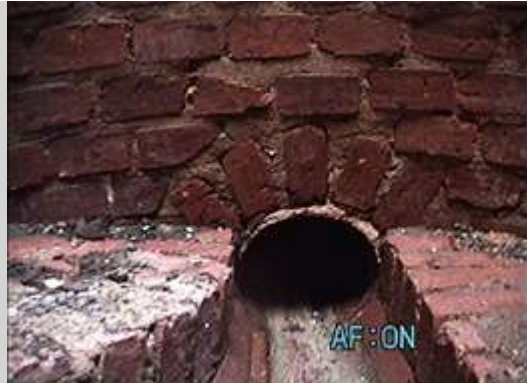
12 O'Clock Outflow

Pipe Height: **8.4** (in.) Rod and Bar (Angled)
Pipe Material: **Clay** ☐ Pipe Lined
Invert Depth: **10.08** (ft.) Flow Characteristics: **None**
Deposits: ☒ None ☐ Mud ☐ Sludge ☐ Debris ☐ Grease
Silt Depth: **0** (in.) Deposits Extent:
Infiltration: **None** Pipe Seal Cond: **Sound**

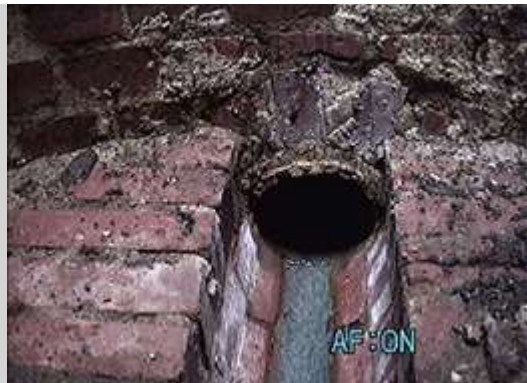
6 O'Clock Inflow

Pipe Height: **6** (in.) Rod and Bar (Angled)
Pipe Material: **Clay** ☐ Pipe Lined
Invert Depth: **9.28** (ft.) Flow Characteristics: **Fast**
Deposits: ☒ None ☐ Mud ☐ Sludge ☐ Debris ☐ Grease
Silt Depth: **0** (in.) Deposits Extent:
Infiltration: **None** Pipe Seal Cond: **Sound**

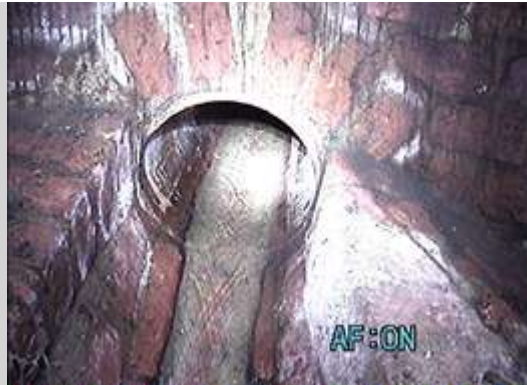
9 O'Clock Inflow

Infiltration: **None** Pipe Seal Cond: **Sound**
